CASE STUDY

Mapware Works with Comcast to Improve Infrastructure Damage Assessments with UAVs

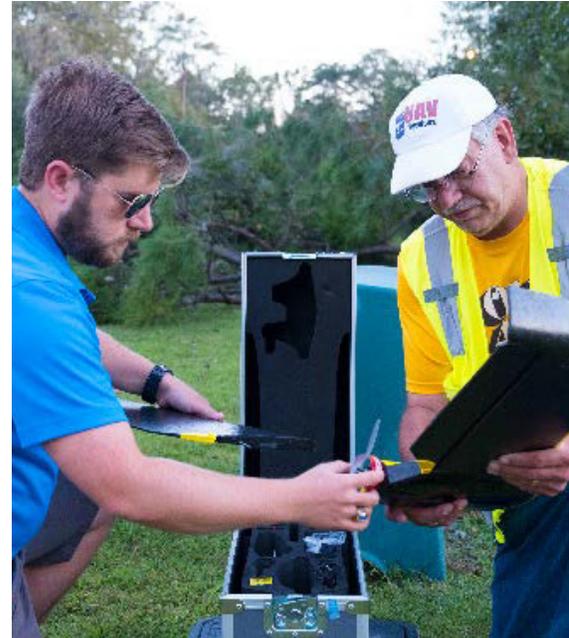
Mapware Chief Pilot Michael Lederman (left) assists a field pilot to set up a SenseFly eBee, the fixed wing UAV system chosen for the Savannah, GA mission.

To allow the storm's trajectory time to manifest itself, crews began staging in Atlanta with system checks and training procedure reviews. For this mission, Mapware chose a fixed-wing system over multicopter options for its greater

endurance and area coverage. This training time allowed the planning team time to study both potential deployment areas, Savannah and Charleston.

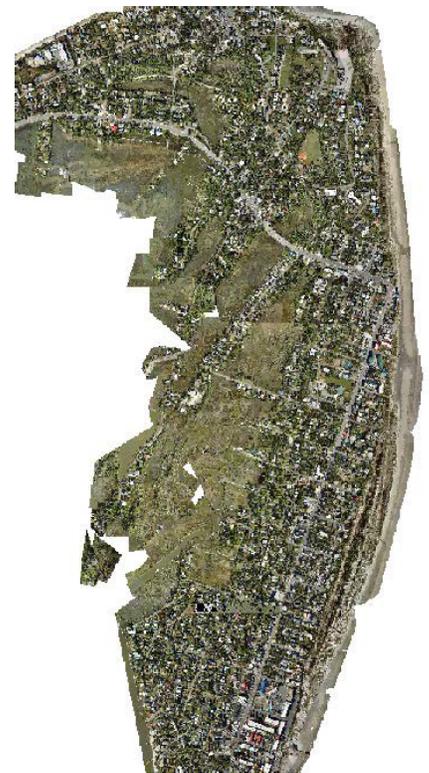
The full orthomosaic created from a series of flights over Savannah, GA. For speed, each tile is analyzed individually for damage before being combined into a larger image.

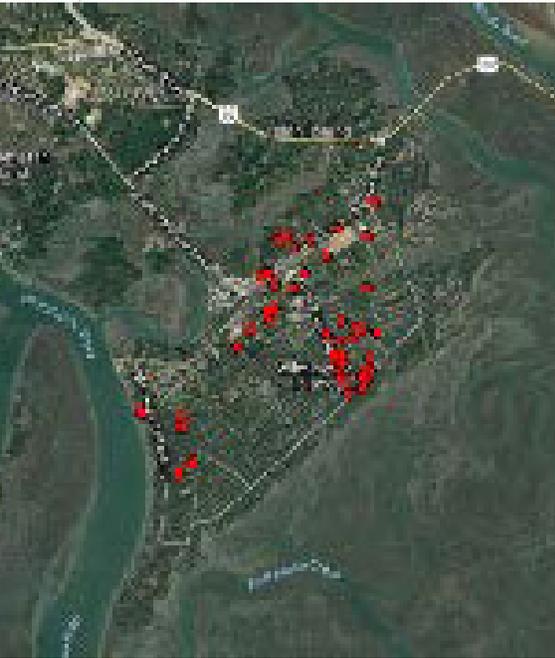
A partial map of the areas around Savannah tagged as damaged. Maps such as this one were delivered daily as new areas were mapped and annotated, along with a spreadsheet of coordinates.

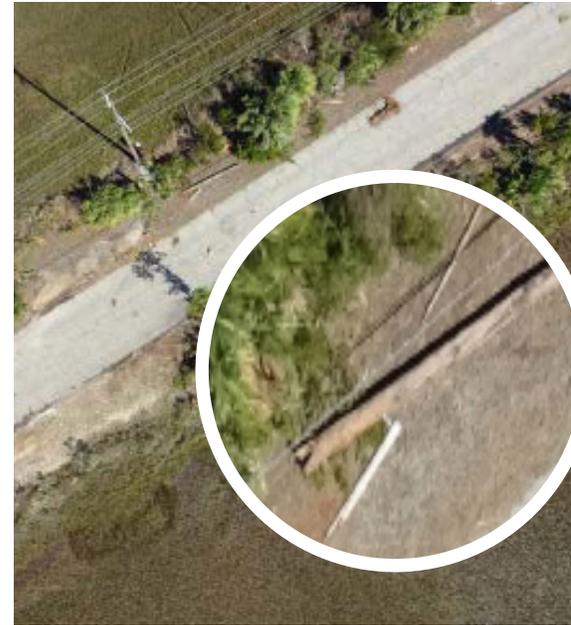
Damage to telephone poles clearly visible from the air. Photos like these were used to identify areas where infrastructure was damaged. Once identified, a location like this one would be tagged with exact coordinates, helping Comcast technicians to quickly locate the downed lines.
